**Flood Control Project Maintenance  
Levee Inspections**

## Maintenance Issue Types Only, Levee Inspection Report By Mile - Spring 2017

### Reclamation District No. 2094 Wathal

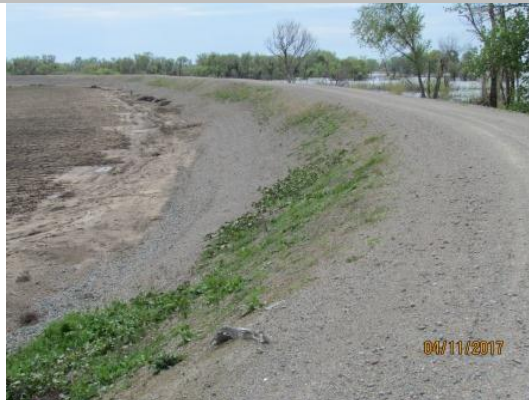
Photo 1 of 1 : SP\_2017\_RD2094\_320\_7\_20170417\_00014.jpg

| Item | Vegetation | | 37.769732 ° | 37.749741 ° | |
| Acceptable vegetation control. | | | | | |

View of the acceptable vegetation control on the levee slope.

| V1 : Control annual grass and weeds on the levee slopes and easements. | | | | | |

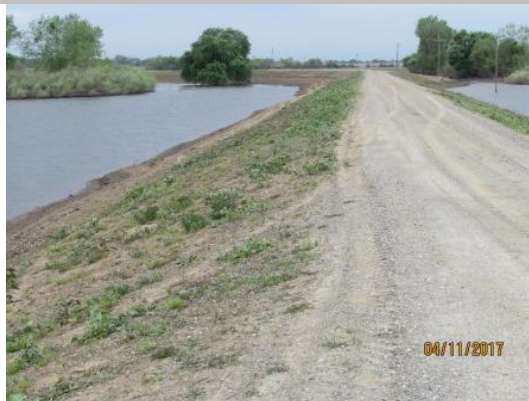
Photo 1 of 1 : SP\_2017\_RD2094\_321\_1\_20170417\_00001.jpg

| Item | Vegetation | | | 37.759253 ° | 37.760602 ° |
| Acceptable vegetation control. | | | | | |

View of the acceptable vegetation on the levee slope.

| V1 : Control annual grass and weeds on the levee slopes and easements. | | | | | |

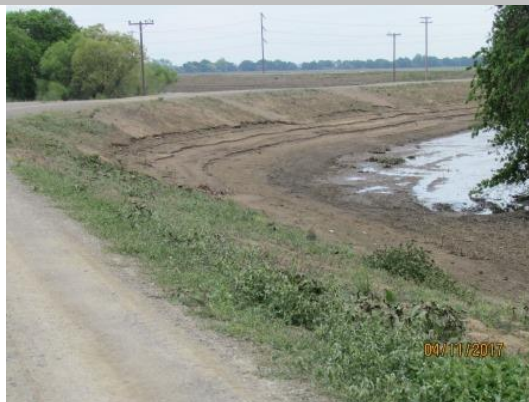
Photo 1 of 1 : SP\_2017\_RD2094\_321\_2\_20170417\_00002.jpg

| Item | Erosion / Bank Caving | | | 37.759549 ° | 37.760616 ° |

View of the wave wash erosion on the levee slope.

| E2 : Schedule repair of erosion site prior to the next inspection. | | | | | |
